Manhole Inspection Summary

Manhole # S33AA_030MH

Location Address: **703 CATHEDRAL ST**

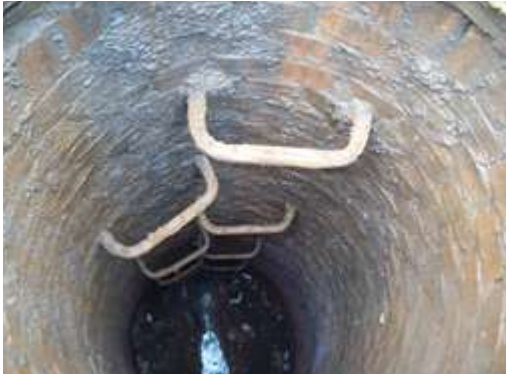
Defect 1

Steps Count: **9** Missing: **0** ☒ **Corroded**

corroded step

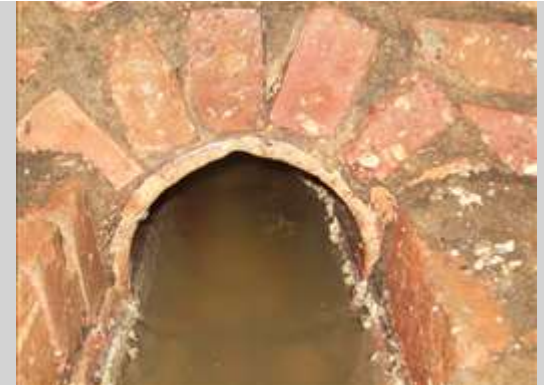
12 O'Clock Outflow

8 in. Circular Gravity Sewer
Pipe Out @ 12 O'Clock

corroded step

Deposits: ☐ None ☐ Mud ☒ **Sludgy** ☐ Debris ☒ **Grease**

Silt Depth: **7** (in.) Deposits Extent: **Heavy**

Infiltration: **Evidence** Pipe Seal Cond: **Unknown**

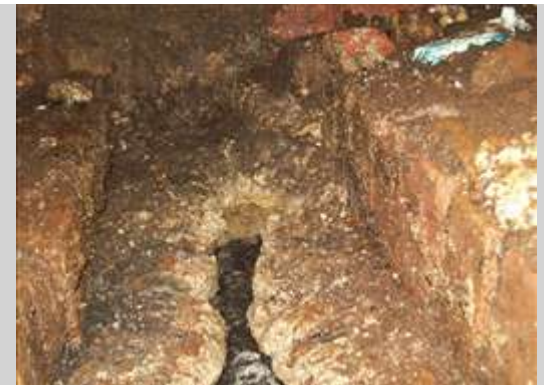
6 O'Clock Inflow

8 in. Circular Gravity Sewer
Pipe In @ 6 O'Clock

CLOGGED W/ GREASE

Deposits: ☐ None ☐ Mud ☒ **Sludgy** ☒ **Debris** ☒ **Grease**

Silt Depth: **3** (in.) Deposits Extent: **Medium**

Infiltration: **Evidence** Pipe Seal Cond: **Unknown**
